Chestnut Hill Waterworks Hall of Machines

Boston, Massachusetts

Final Treatment Report for Steam Pumping Engines

October 2006

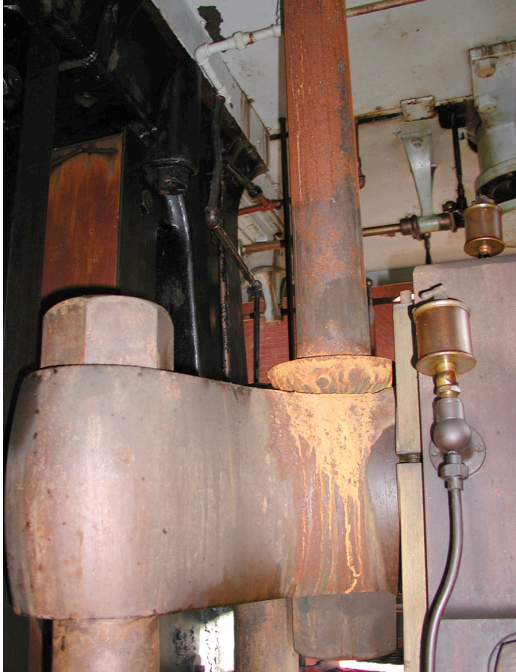
Excessive Rust [iron metal corrosion] (see Figure A1)

Paint spalls and flaky orange deposits indicated the presence of active iron corrosion. Iron is a fairly reactive metal that performs best when coated, protected from high humidity (above 70%) and is kept clean. The engines exhibited two apparent finish/rust conditions prior to treatment. The first of these is exposed iron at surfaces that were originally meant to be painted and now exhibit rust (see Figure B1); the second condition is surfaces that were originally plated that now exhibit rust (see Figure C1). This condition was treated with the vacuum and cleaning procedures mentioned above then coated with Corrosion Suppressant 101 (bare metal only, not intact paint) manufactured by Aervoe Industries, Inc (see Figures A2, B2 and C2).

The rust resulting from both conditions, but particularly the formerly plated surfaces, appears to be caused by galvanic corrosion. This is a chemical reaction that occurs when dissimilar metals are in fixed contact in the presence of an electrolyte. The metal that is lower on the electromotive scale will preferentially give up ions to the metal that is higher (see Figure D1). It was observed that even the plaque, installed in 1972, which consists of bronze (estimated) on a ferrous metal base, is already corroding at the ferrous surface (see Figure E1). This surface to surface contact assembly of dissimilar metals is considered to be an inherent vice of these pumping engines. Further information from National Park Service Historian, Duncan Hay indicates this construction technique of employing adjacent dissimilar metals to manage machinery movement stresses may have

Figure A1. Extensive rust evident on Allis engine before treatment.

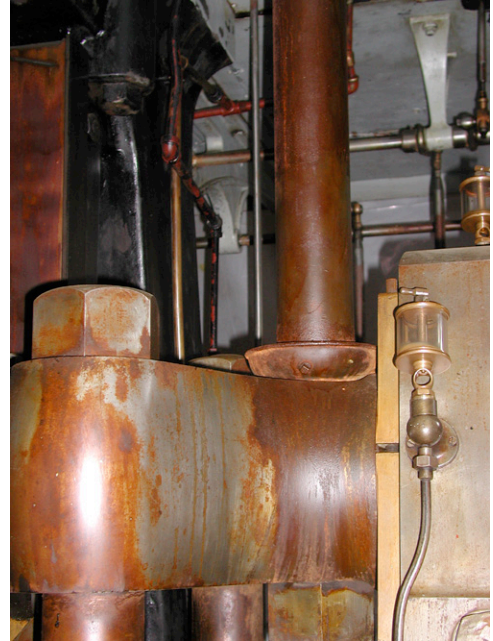
Figure A2. Rusted metal surfaces cleaned with mineral spirits and coated with Corrosion Suppressant 101- Allis engine after treatment.

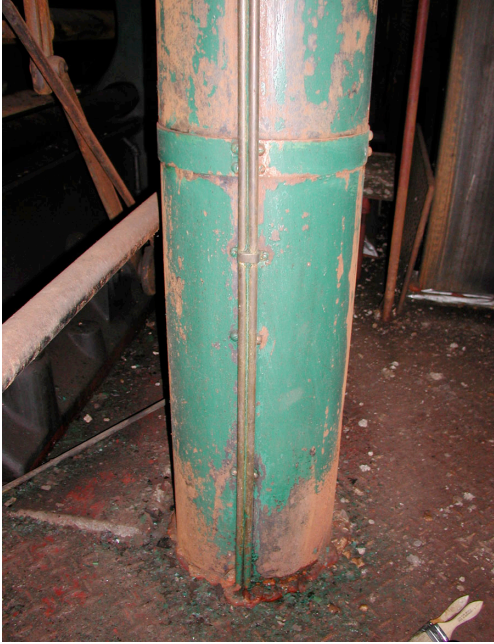
Figure B1. Originally painted surface, exhibiting extensive rust, Worthington engine before treatment.

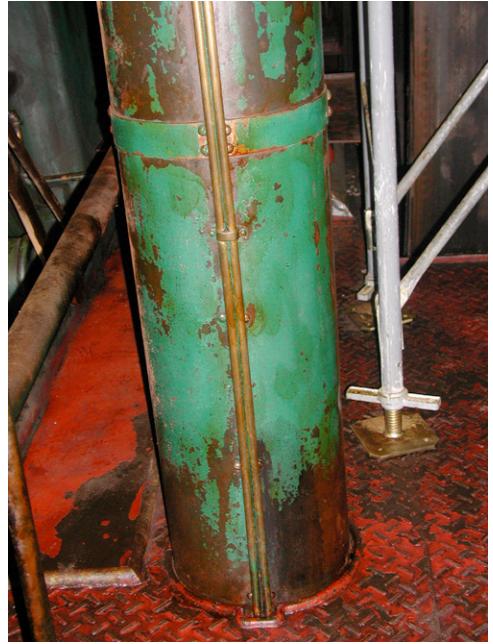
Figure B2. Originally painted surface, Worthington engine after treatment.

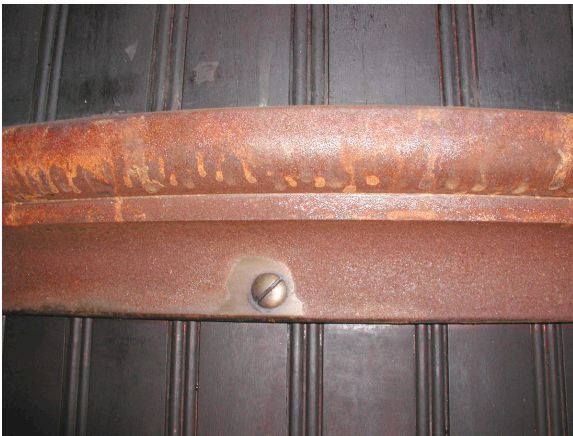
Figure C1. Originally plated surface, exhibiting extensive rust, Leavitt engine before treatment.

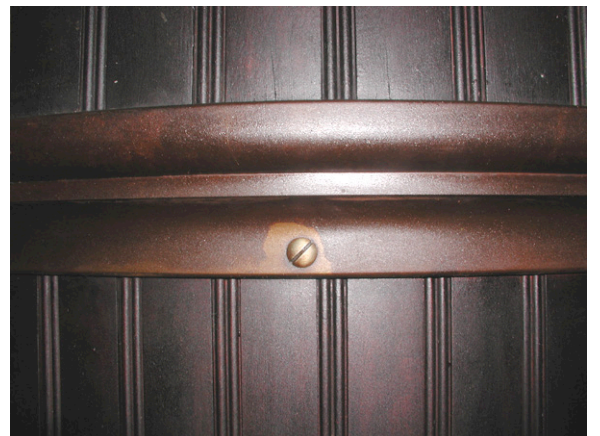
Figure C2. Originally plated surface, Leavitt engine after treatment.

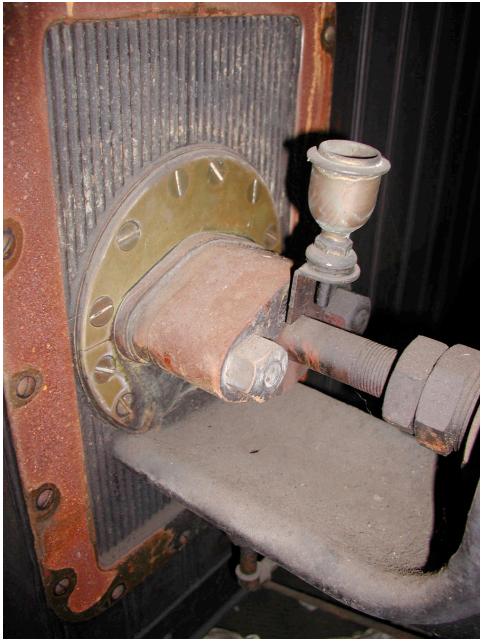
Figure D1. Galvanic corrosion (see surround plate) Leavitt engine before treatment.

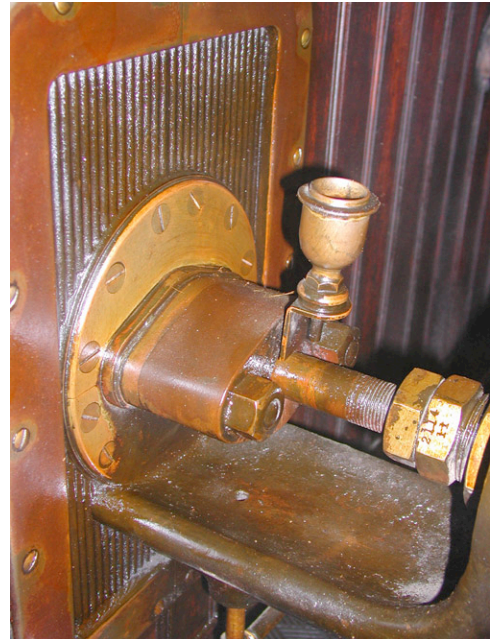
Figure D2. Galvanic corrosion Leavitt engine after treatment.

been the engineer's original design intent. Thus this condition was treated identically to the rusted surfaces mentioned above - cleaned with mineral spirits and nylon scrub pads and coated with Corrosion Suppressant 101 (see Figures D2 and E2).

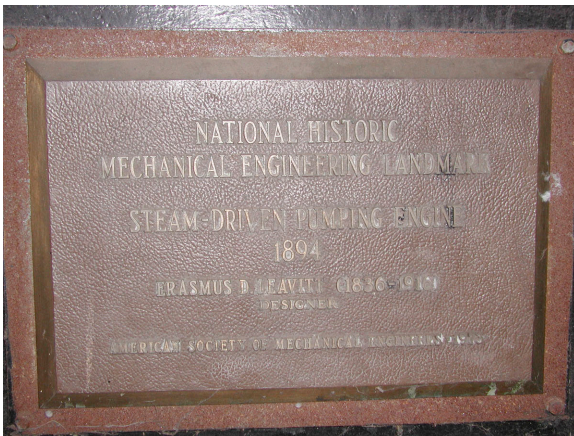
Figure E1. Galvanic corrosion Leavitt engine before treatment.

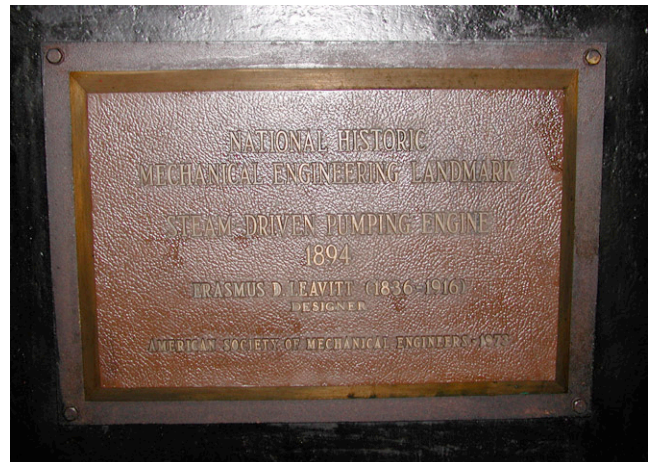
Figure E2. Galvanic corrosion Leavitt engine after treatment.

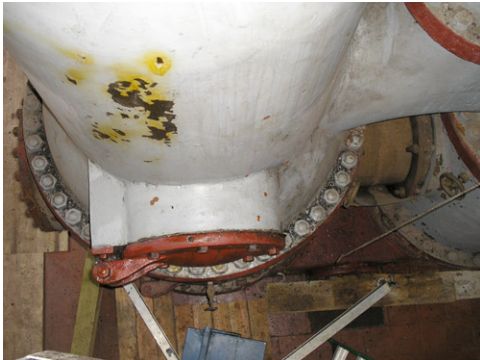
Figure F1. Worthington engine north end with CS 101 corrosion suppressant coating.

At the request of Dana Angelo, EA Fish, Senior Project Director, the light gray painted engine components of the Worthington engine at the north end were coated with an alternate corrosion suppressant coating (due to unacceptable yellowish color of Aervoe product on light gray paint surfaces). These surfaces were coated instead with 3-36 Multi Purpose Lubricant and Corrosion Inhibitor manufactured by CRC (see Figures F1 and F2).

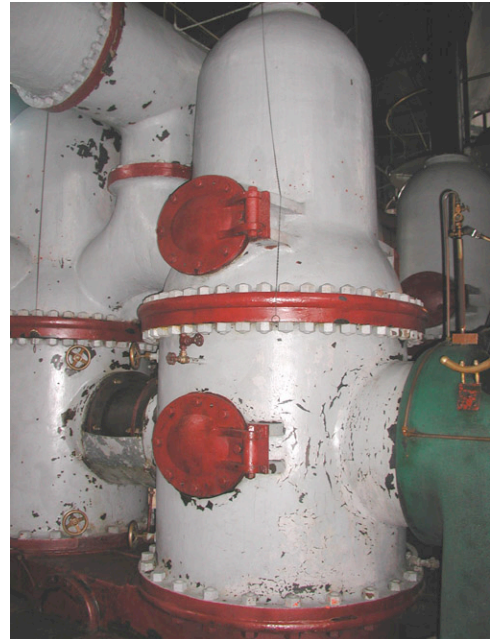
Figure F2. Worthington engine with CRC 3-36 corrosion suppressant coating.

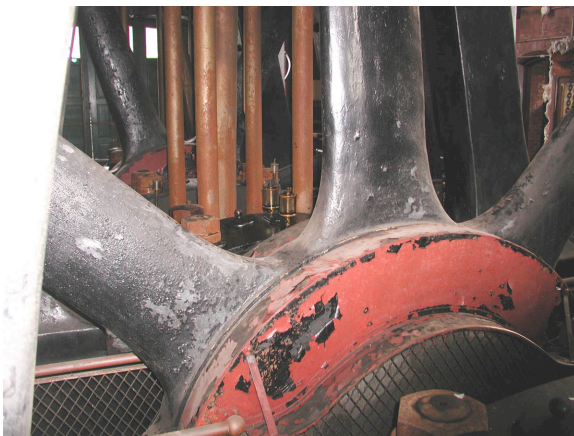
Paint Failure (see Figure G) – Much paint is peeling, chipping and flaking off of the machines' surfaces. The finish analysis study completed by BCA in March 2006 revealed complex paint histories on the various pumping engines as well as on their color coded parts. Neither the contemporary pump schemes, nor the part designation color schemes could be easily disseminated or deciphered in concurrent chronological context. Therefore retention of the paint layers for future research was the goal and the product of this treatment. At these flaking areas, BCA gently eased off non-adhered paint flakes with thin plastic spatulas (softer than the metal to prevent scratching), then vacuumed. The adjacent bare metal was cleaned with mineral spirits and coated with Corrosion Suppressant 101 (see Figure G2). Future engine interpretation will no doubt be aided by BCA's exposure of numbered engine parts previously obscured by grease and grime (see Figures I1 and I2).

Figure G1. Paint failure at wheel of Allis engine before treatment.

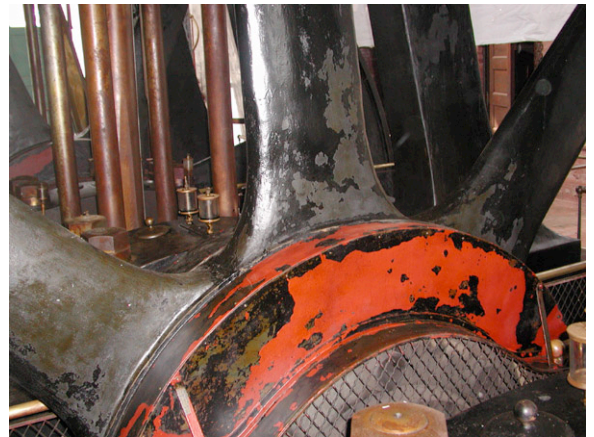
Figure G2. Paint failure at wheel of Allis engine after treatment.

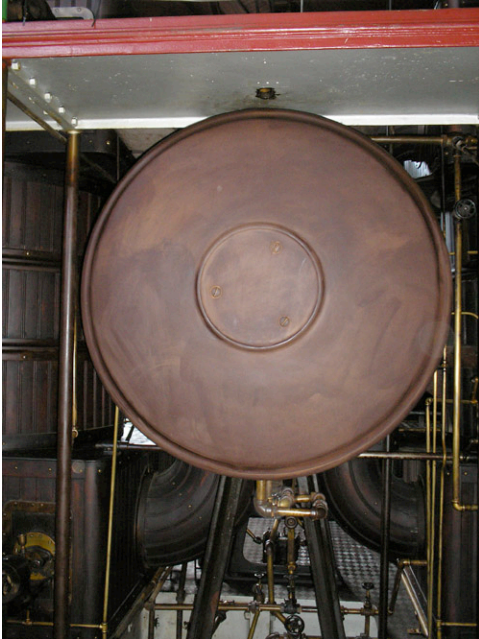
Figure H1. Leavitt engine rusted barrel end before CRC 3-36/microcrystalline wax treatment.

Halfway through the engines treatments, a third rusted metal treatment possibility was provided by National Park Service associate Greg Byrne. This treatment consists of heating microcrystalline wax and combining it with a 20% weight to volume portion of CRC 336. Since advisory board member Duncan Hay was a strong advocate of this treatment, BCA tested its use on two of the third floor barrel end elements of the Leavitt engine (the north elevation east one and the south elevation west one). Although satisfactory in appearance, this treatment proved to be impractical to implement given the time constraints of this project (see Figures H1 and H2).

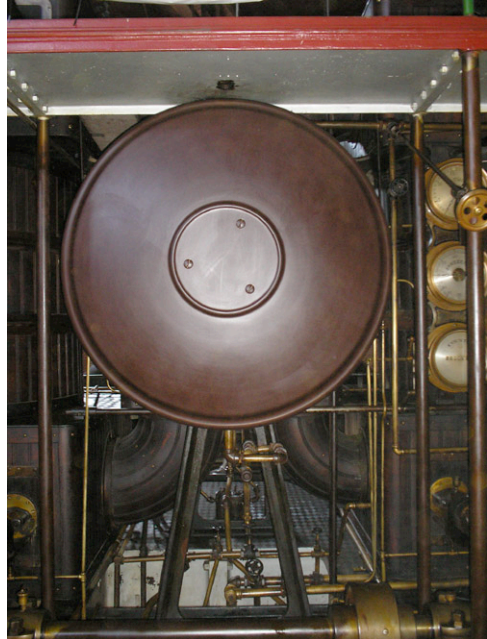
Figure H2. Leavitt engine rusted barrel end after CRC 3-36/microcrystalline wax treatment.

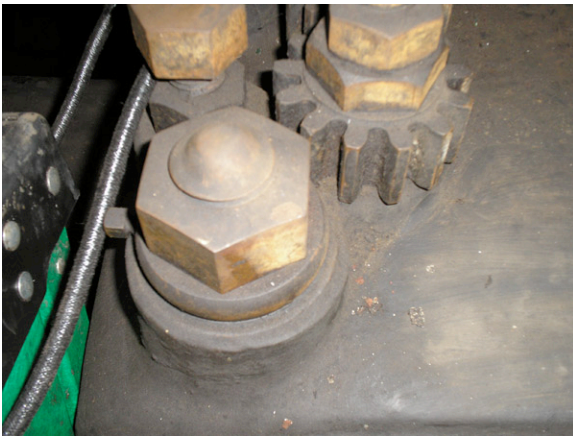
Figure I1. Leavitt engine, first floor bolt, detail before cleaning.

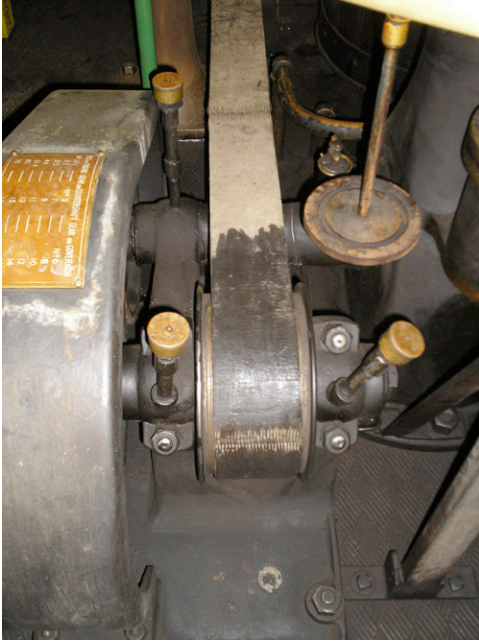
Figure J1. Leavitt engine leather belt during cleaning w/1% diammonium citrate cleaner. citrate.

BCA cleaned the leather engine belts with mild gel cleaner containing 1% of the chelator diammonium citrate and 1% of the non-ionic surfactant Triton XL-80N in water gelled with methylcellulose to prevent over dampening of the brittle leather (see Figures J1 and J2).

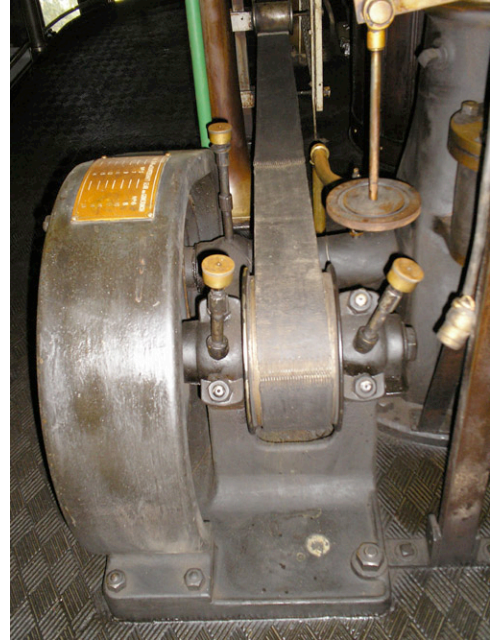
Figure J2. Leavitt engine leather belt after cleaning w/ 1% diammonium citrate.
