Chestnut Hill Waterworks Hall of Machines

Boston, Massachusetts

Final Treatment Report for Steam Pumping Engines

October 2006

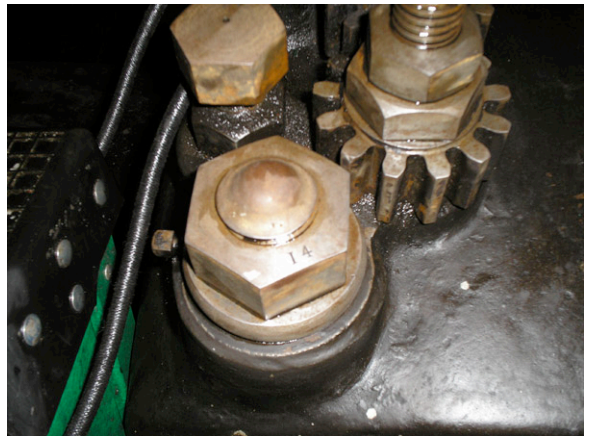
Paint Failure (see Figure G) – Much paint is peeling, chipping and flaking off of the machines' surfaces. The finish analysis study completed by BCA in March 2006 revealed complex paint histories on the various pumping engines as well as on their color coded parts. Neither the contemporary pump schemes, nor the part designation color schemes could be easily disseminated or deciphered in concurrent chronological context. Therefore retention of the paint layers for future research was the goal and the product of this treatment. At these flaking areas, BCA gently eased off non-adhered paint flakes with thin plastic spatulas (softer than the metal to prevent scratching), then vacuumed. The adjacent bare metal was cleaned with mineral spirits and coated with Corrosion Suppressant 101 (see Figure G2). Future engine interpretation will no doubt be aided by BCA's exposure of numbered engine parts previously obscured by grease and grime (see Figures I1 and I2).

Figure I2. Leavitt engine, first floor bolt detail after cleaning. Note number now visible.

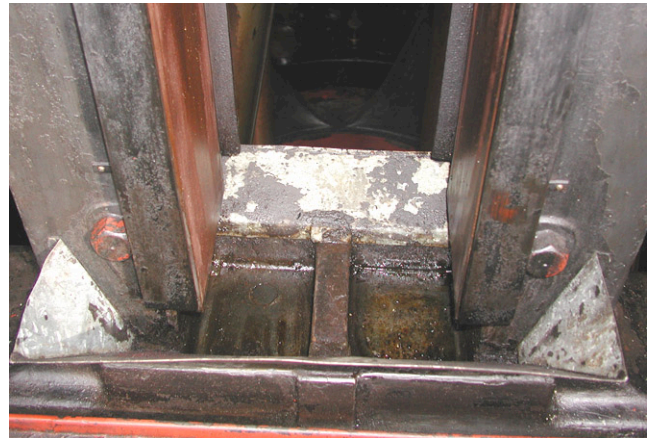
Figure K2. Standing oil build-up at Allis engine after treatment.

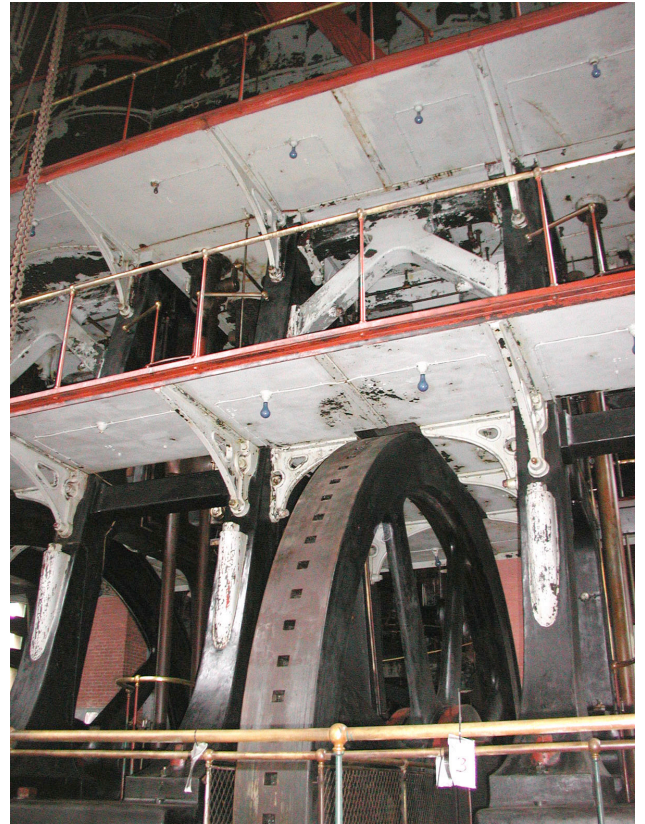
Allis engine (west) after treatment August 30, 2006.

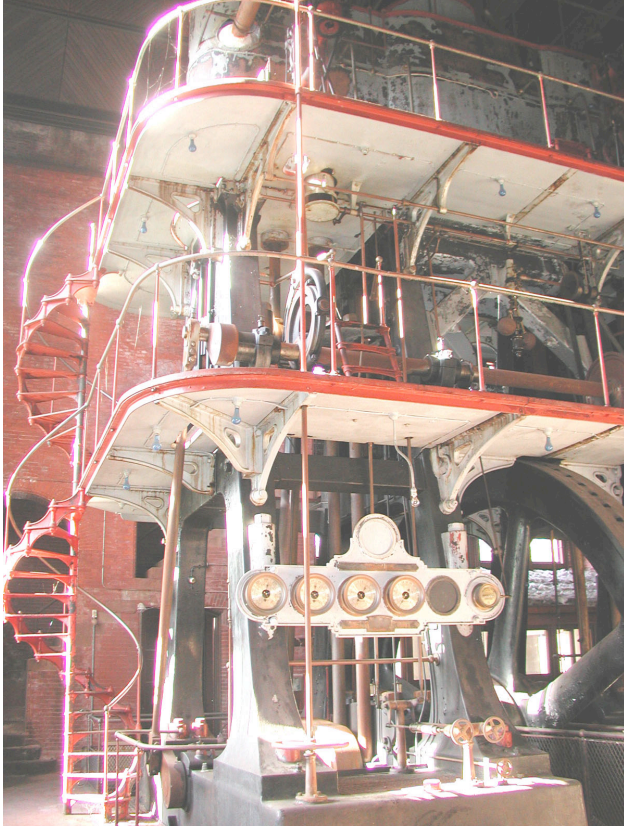
Allis engine (southeast elevation) before Treatment November 21, 2005.

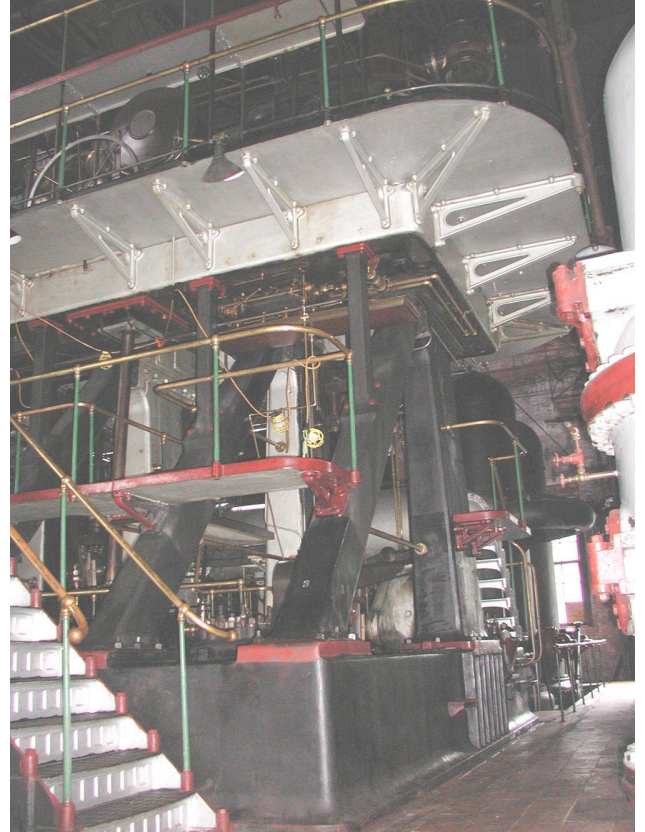
Leavitt engine (northwest) after treatment August 30, 2006.

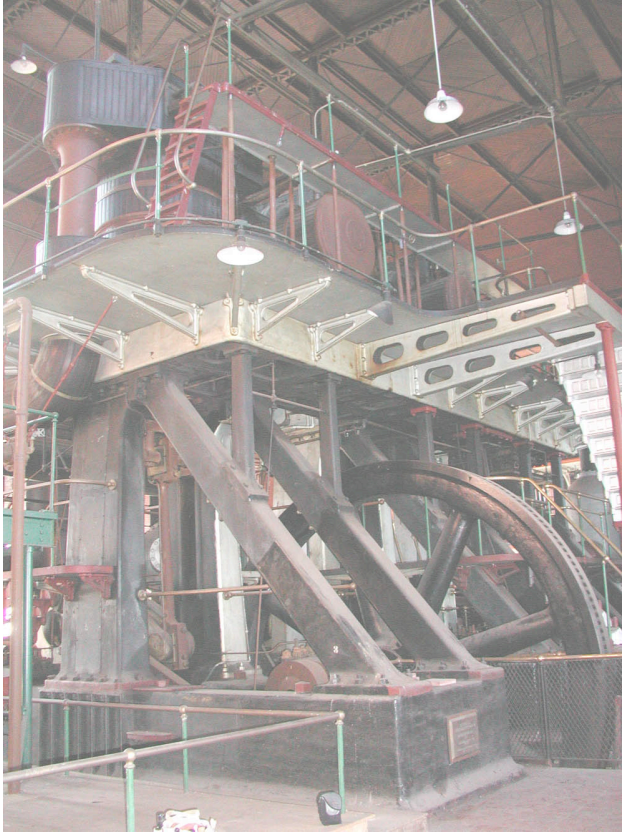
Leavitt engine (northeast elevation) before treatment November 21, 2005.

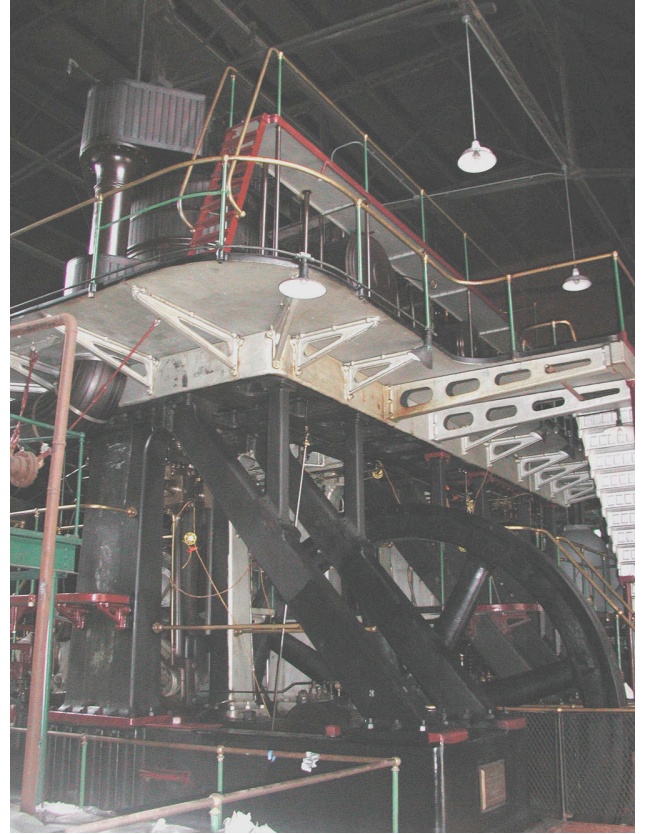
Leavitt engine (northeast) after treatment August 30, 2006.

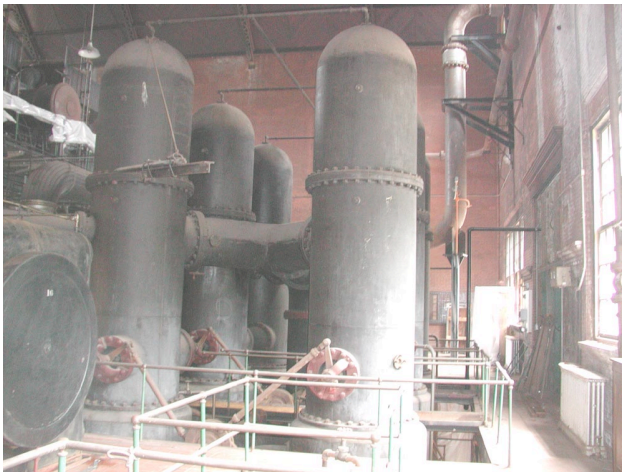
Leavitt engine (southwest) before treatment June 28, 2006.

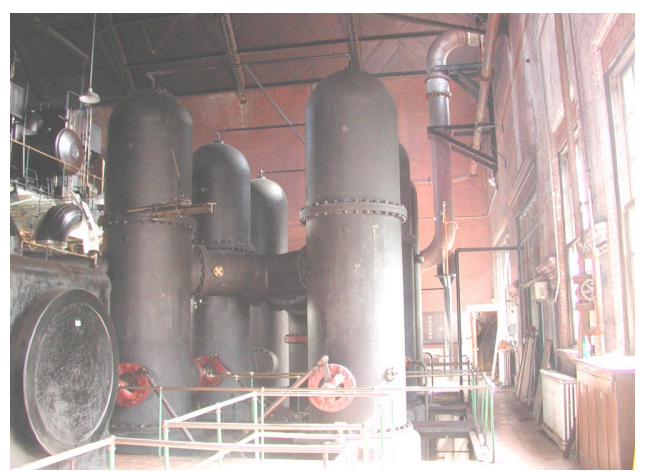
Leavitt engine (southwest) after treatment August 30, 2006.

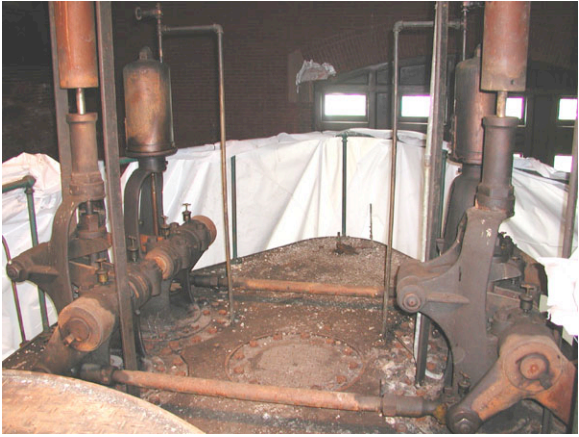
Allis Floor 4 North detail A before treatment.

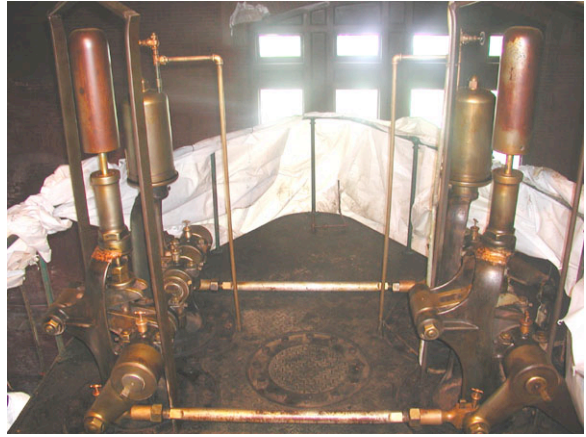
Allis Floor 4 North detail A after treatment.

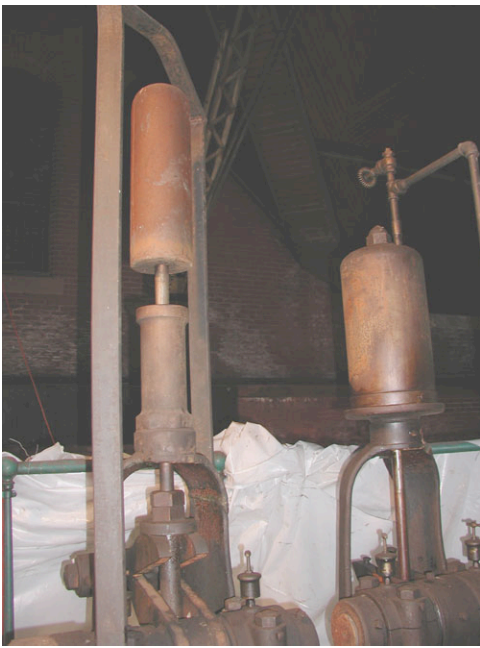
Allis Floor 4 North detail B before treatment.

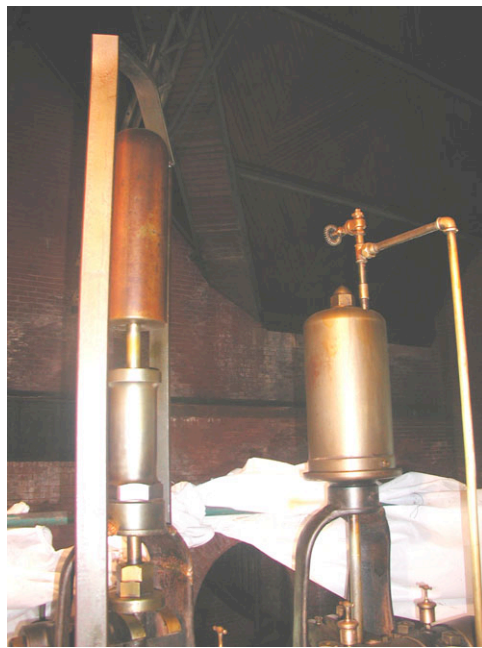
Allis Floor 4 North detail B after treatment.

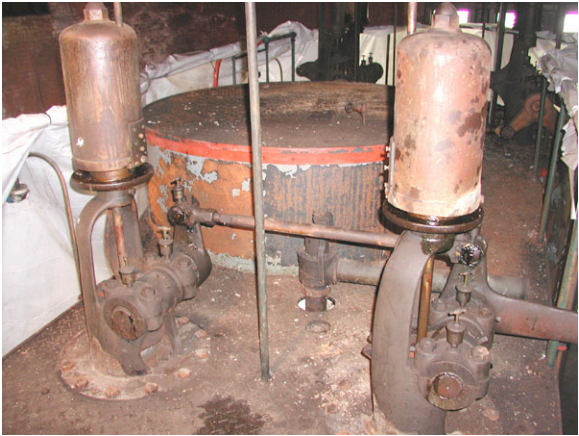
Allis Floor 4 mid detail C looking north before treatment.

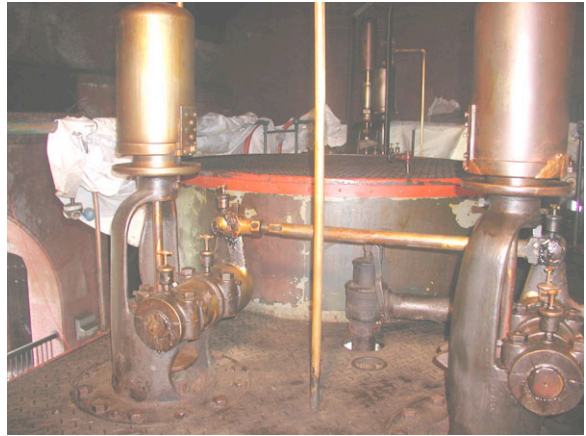
Allis Floor 4 mid detail C looking north after treatment.

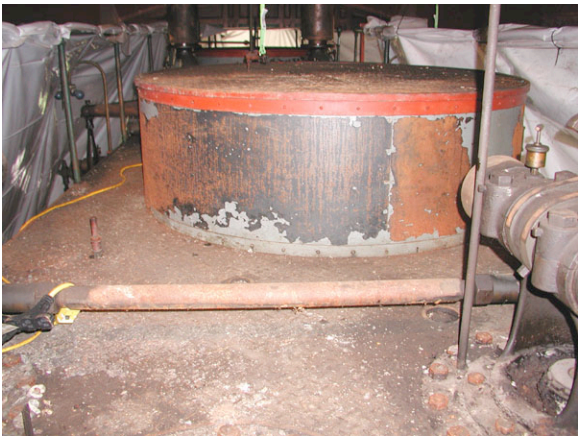
Allis Floor 4 North detail D barrel looking south before treatment.

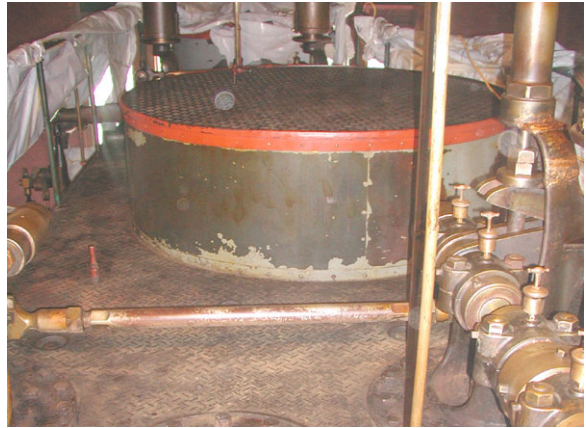
Allis Floor 4 North detail D barrel looking south after treatment.

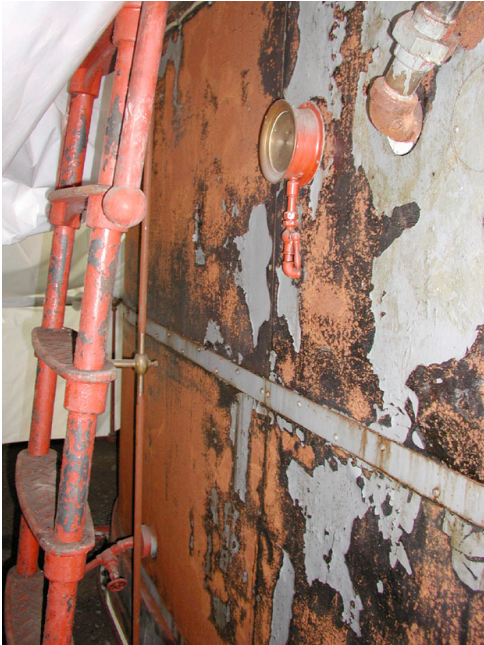
Allis Floor 3 North detail A, west side looking north before treatment.

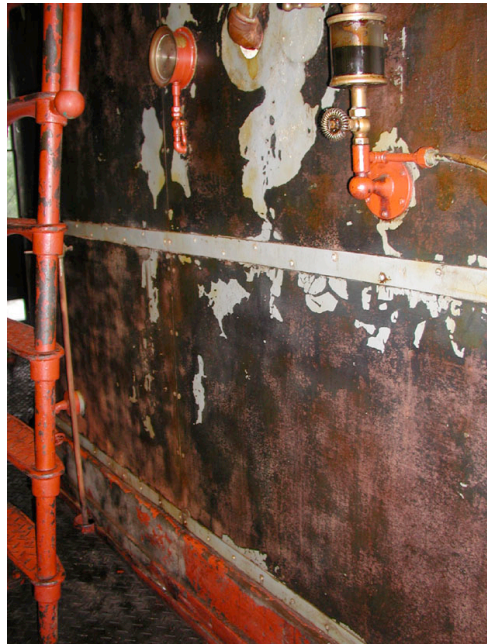
Allis Floor 3 North detail B, west side after treatment.

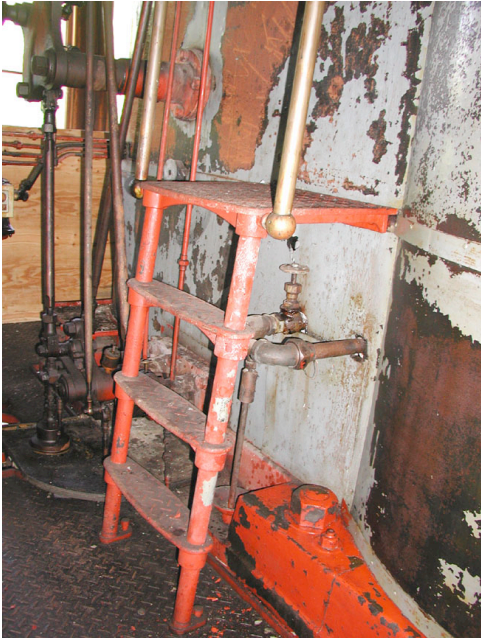
Allis Floor 3 South detail C, east side looking south before treatment.

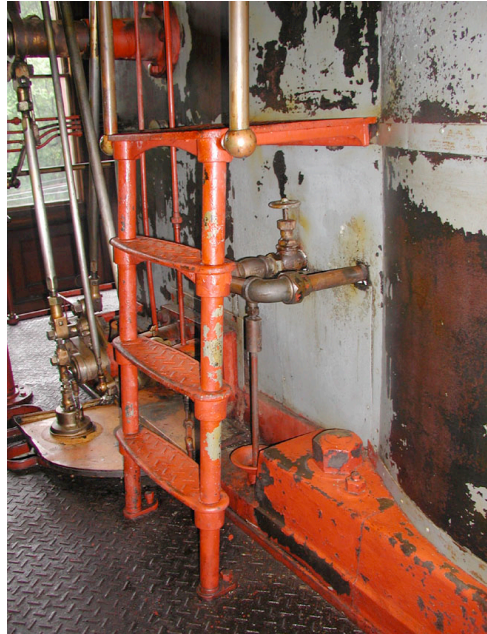
Allis Floor 3 South detail D, east side looking south after treatment.

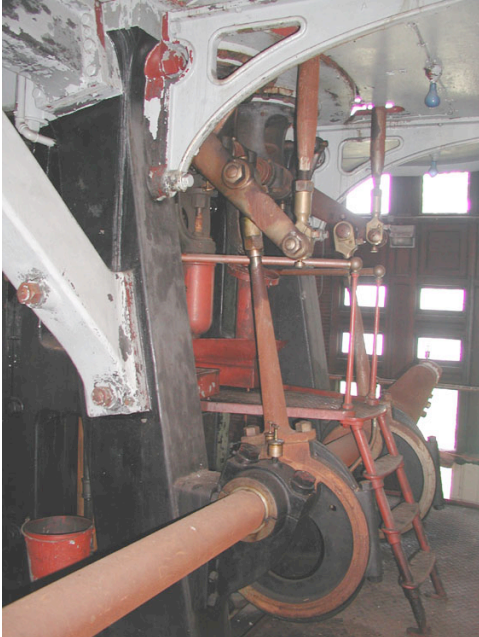
Allis Floor 2 South detail A, west side looking south before treatment.

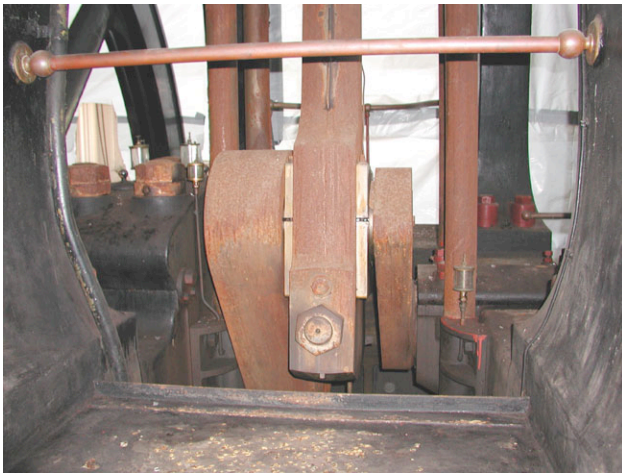
Allis Floor 1 North detail C, east side before treatment.

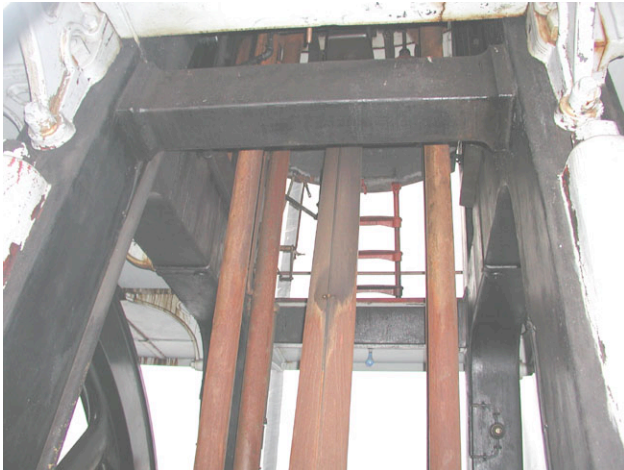
Allis Floor 1 North detail E, east side before treatment.

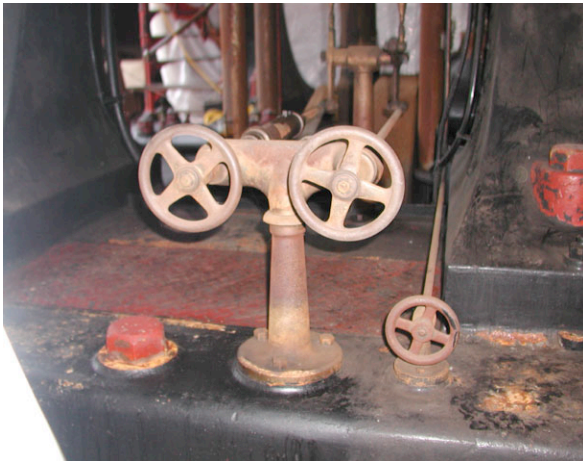
Allis Floor 1 South detail G, east side before treatment.

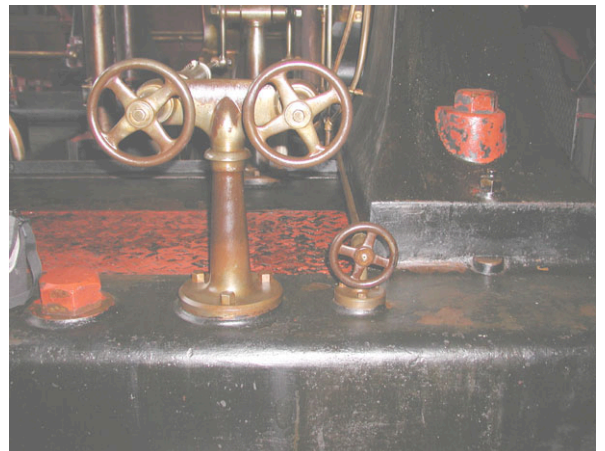
Allis Floor 1 South detail H, east side after treatment.

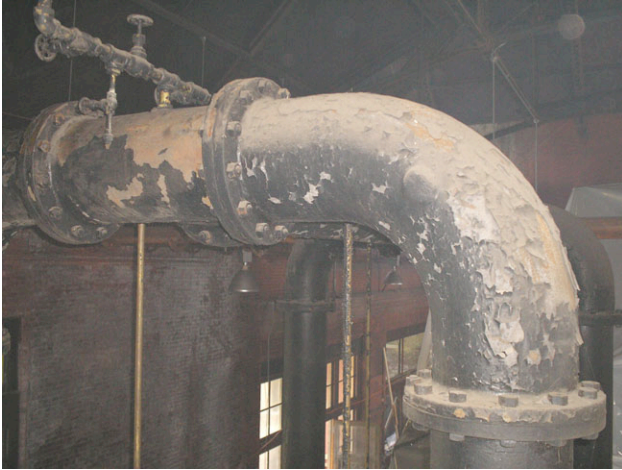
Worthington Floor 3 North detail A,
before treatment.

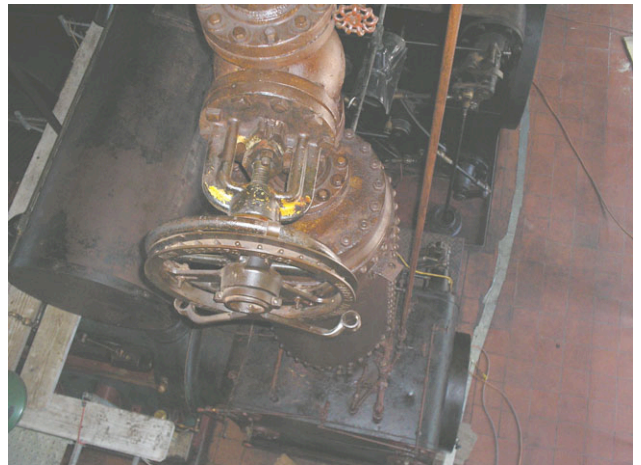
Worthington Floor 3 South
detail D, after treatment.

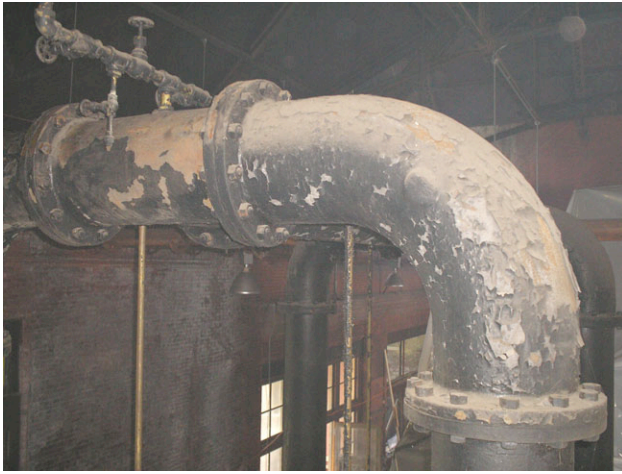
Worthington Floor 3 North detail A,
before treatment.

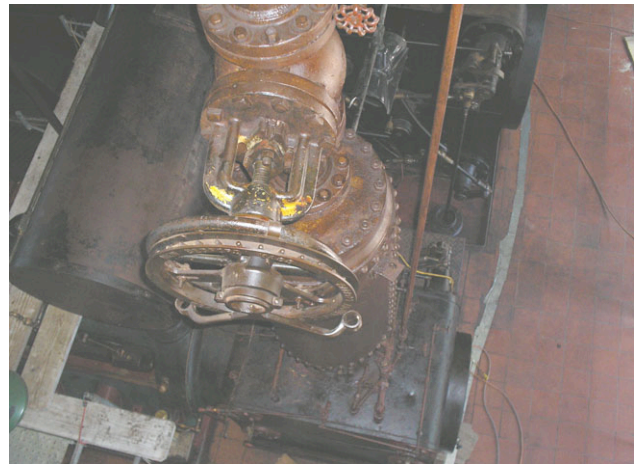
Worthington Floor 3 South
detail D, after treatment.

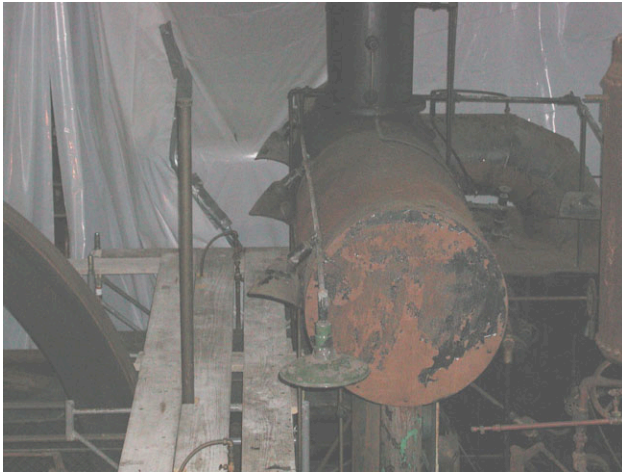
Worthington Floor 2 mid detail A,
looking east before treatment.

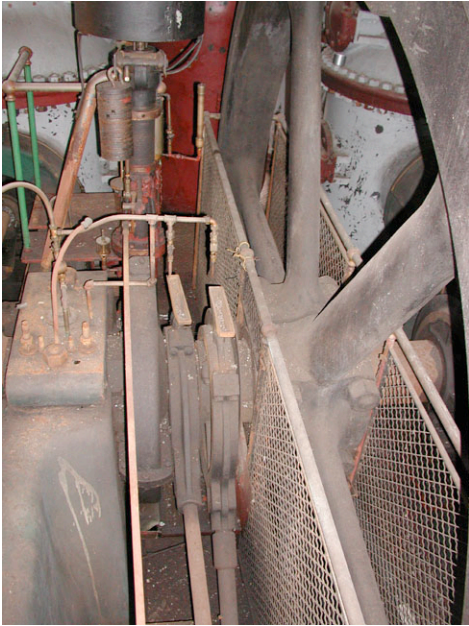
Worthington Floor 1 mid detail A, looking north before treatment.

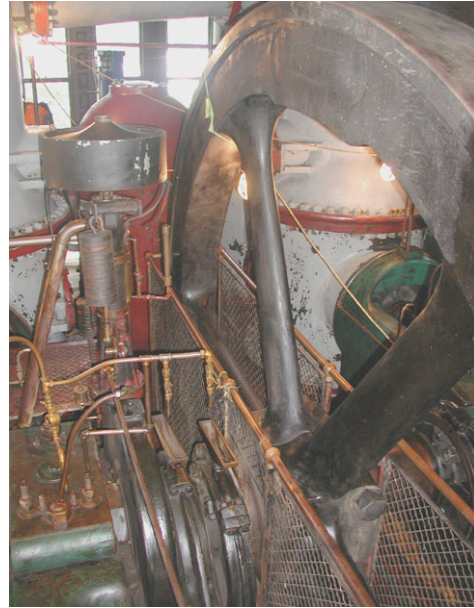
Worthington Floor 1 mid detail B, after treatment.

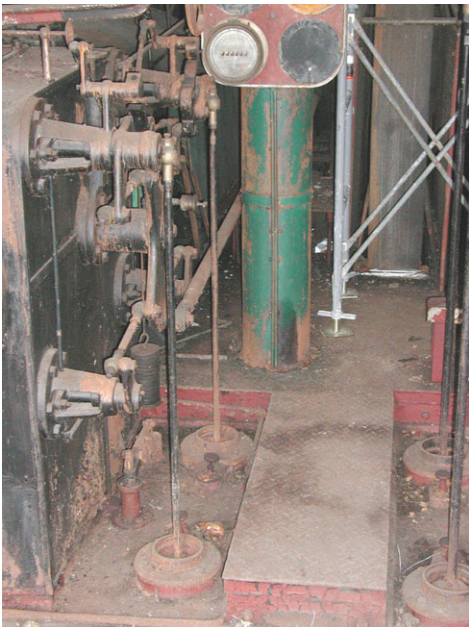
Worthington Floor 1 North detail C, looking north before treatment.

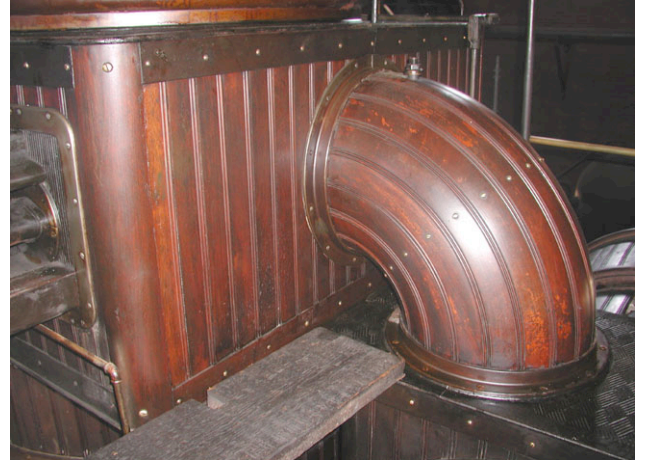
Leavitt Floor 4 North
detail B, after treatment.

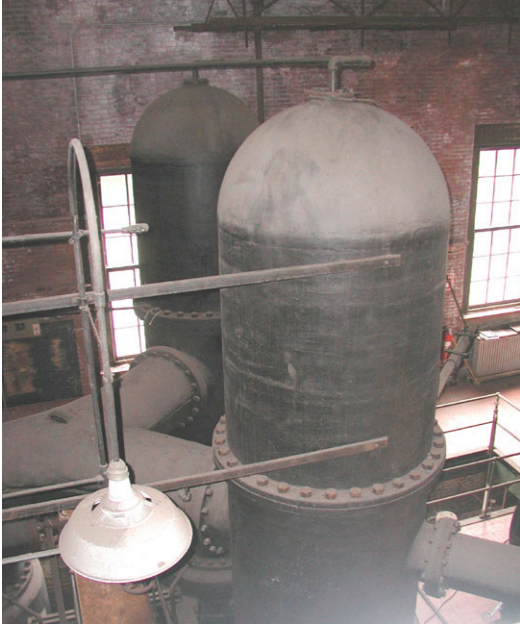
Leavitt Floor 4 South detail E,
looking south before treatment.

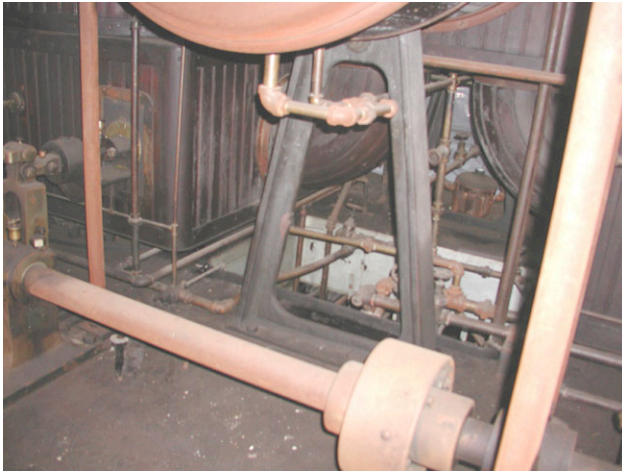
Leavitt Floor 3 North detail A,
north side before treatment.

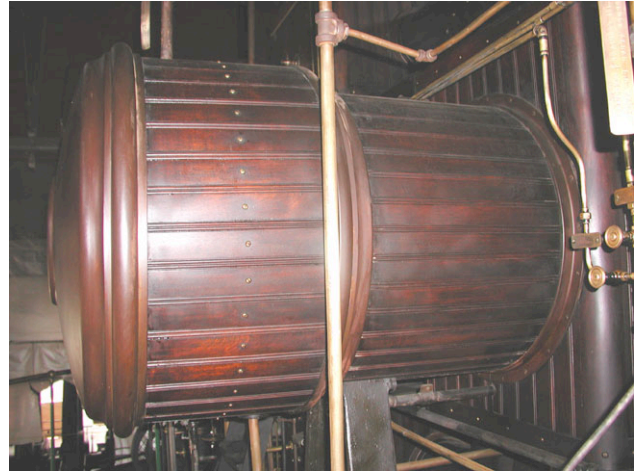
Leavitt Floor 3 North end detail F, south side after treatment.

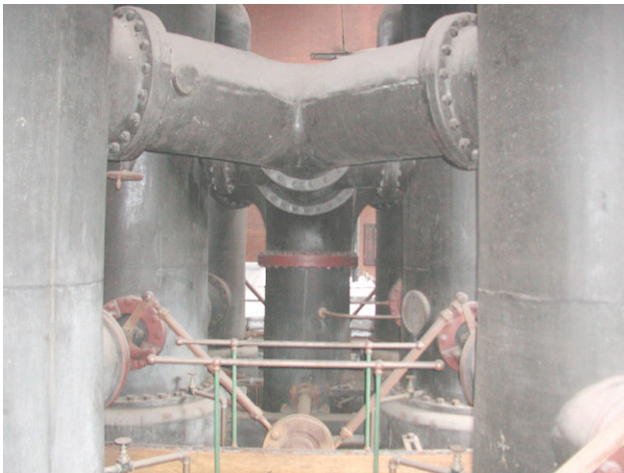
Leavitt Floor 3 South detail G, looking east before treatment.

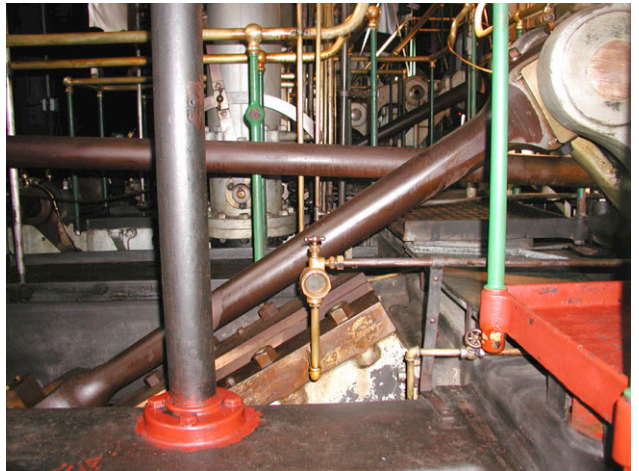
Leavitt Floor 2 North end detail D, east side after treatment.

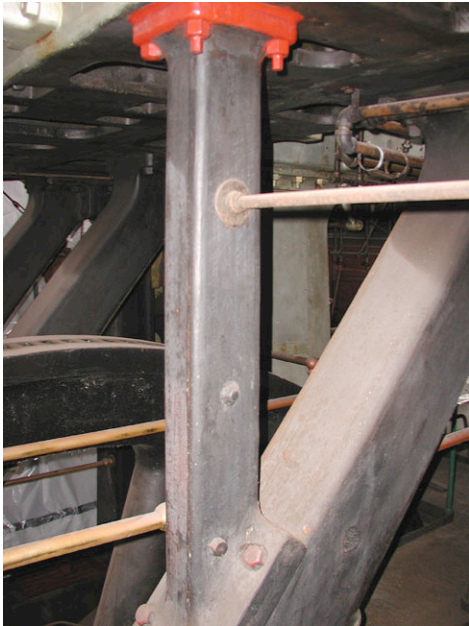
Leavitt Floor 2 North end detail E, north side before treatment.

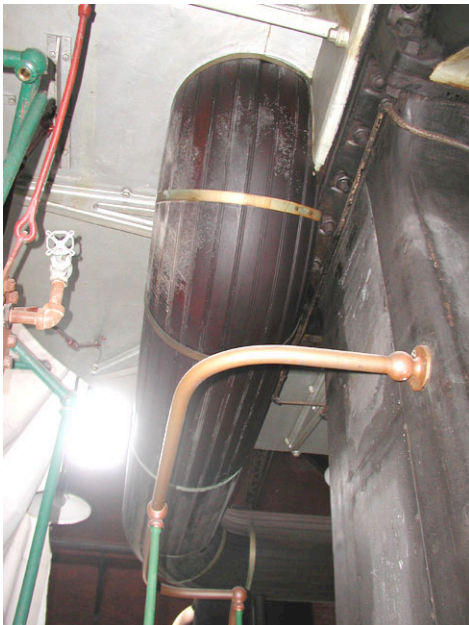
Leavitt Floor 2 North end detail G, east side before treatment.

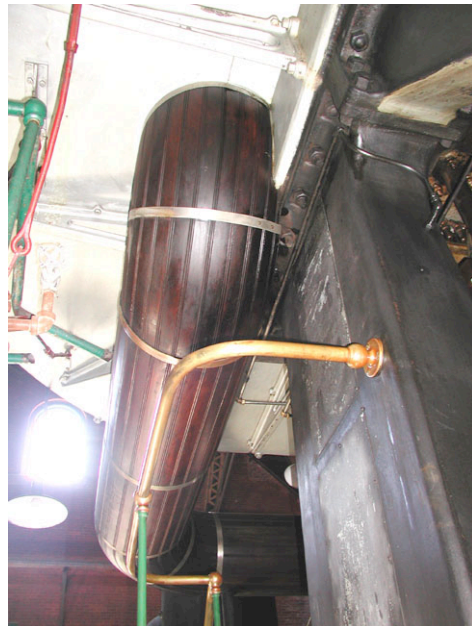
Leavitt Floor 2 North end detail H, after treatment.
