Chestnut Hill Waterworks Hall of Machines

Boston, Massachusetts

Final Treatment Report for Steam Pumping Engines

October 2006

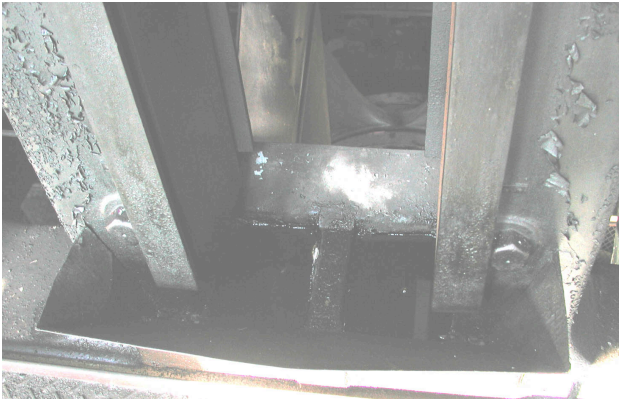
Figure K1. Standing oil build-up at Allis engine before treatment.

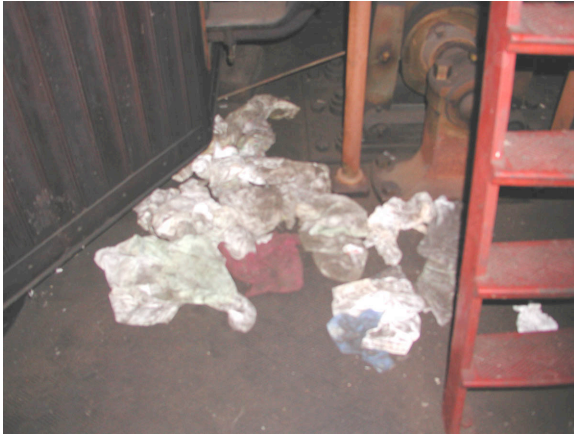
Figure L1. Oily rags Leavitt engine third floor before treatment.

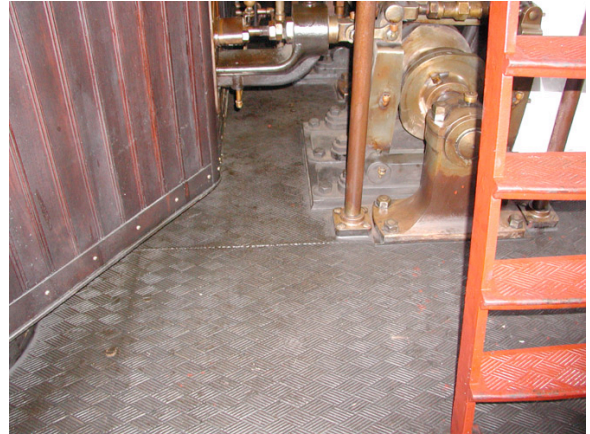
Figure L2. Same area after treatment.

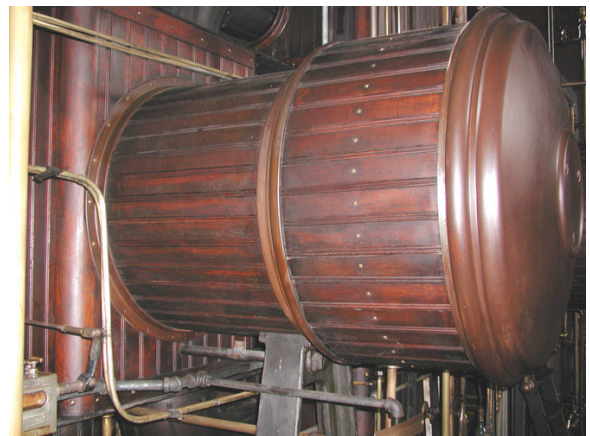
Fortunately, translucent wood finishes on the Leavitt engine were also successfully cleaned with the Tergitol emulsion. This was advantageous because wood and metal elements were so integrated at the third floor of the Leavitt engine that some overlap did occur during cleaning. It should be noted that because of the fragile nature of translucent wood finishes the dwell time of the Tergitol emulsion on these surfaces was limited to 1 minute maximum. To protect these surfaces following cleaning and drying a protective coating of Archival Varnish incorporating ultraviolet light filters was applied. This product was Mineral Spirit Acrylic Aerosol (Satin) manufactured by Golden (see Figure M2).

Figure M2. Finished wood elements at Leavitt engine after treatment.

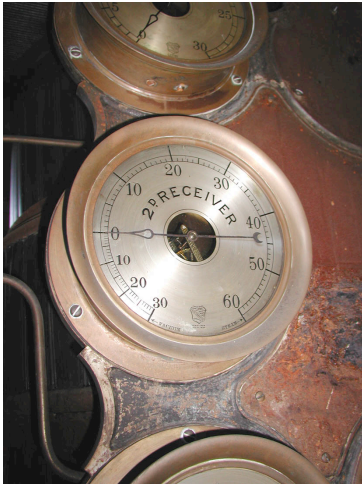
Figure N1. Finely worked gauges at Leavitt engine before treatment.

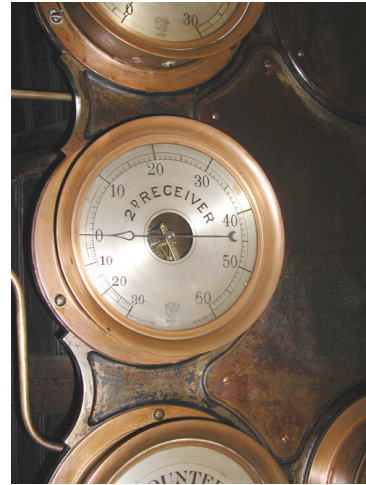
Figure N2. Finely worked gauges at Leavitt engine after treatment.

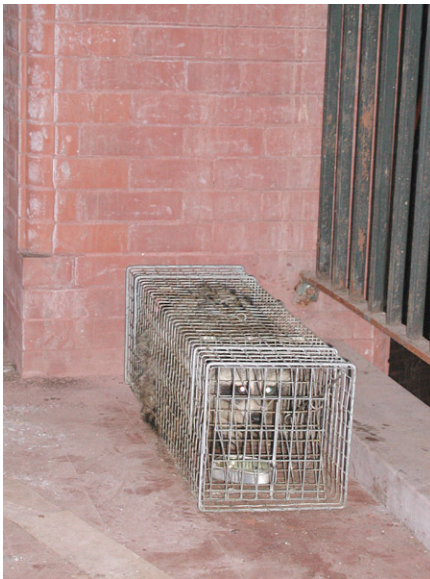
During a visit by National Park Service Historian, Duncan Hay, several raccoons were noted at the west third floor balcony of the building. Subsequent trapping initiated by NEI, succeeded in the capture of one of these rodents (see Figure O). Further monitoring of rodent evidence should be performed weekly until the building has been better-sealed post construction phase.

Figure O. Raccoon captured at second floor west balcony July 20, 2006.

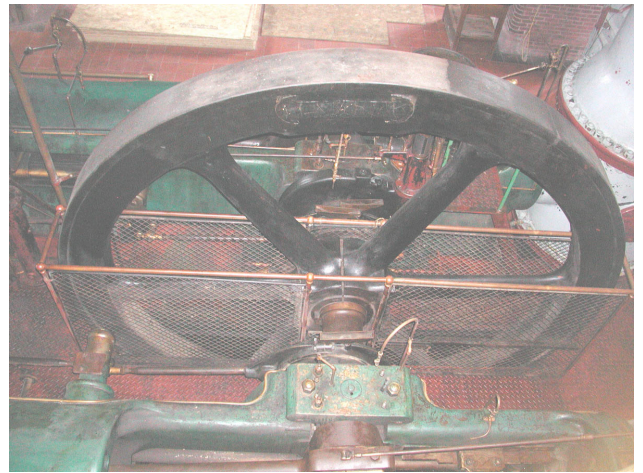
Worthington engine (middle) after
treatment August 30, 2006.

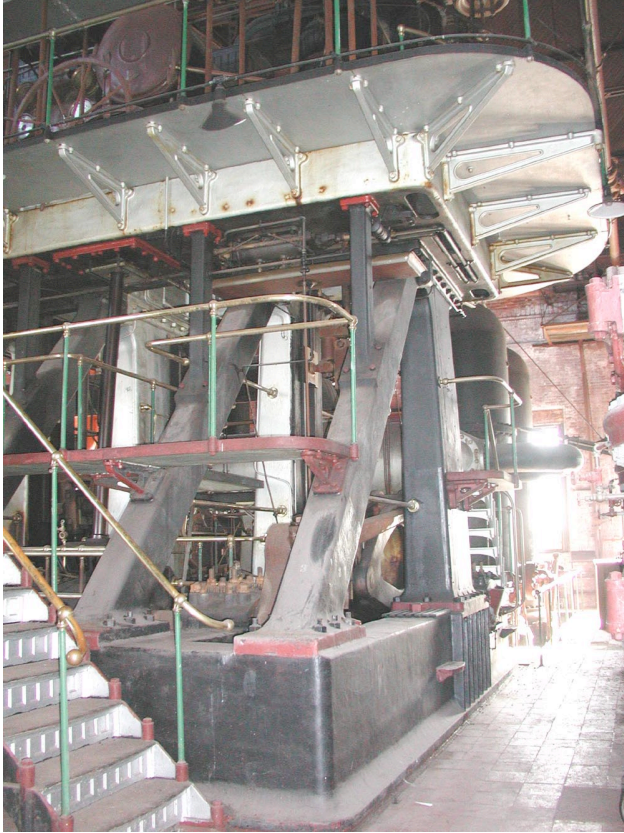
Leavitt engine (northwest elevation) before treatment November 21, 2005.

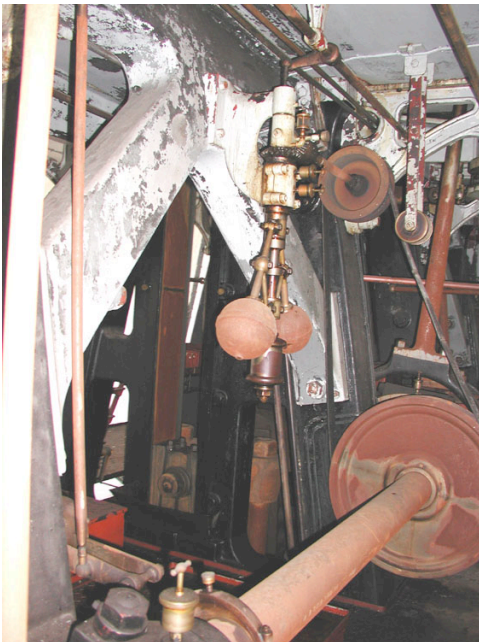
Allis Floor 2 mid detail C east side before treatment.

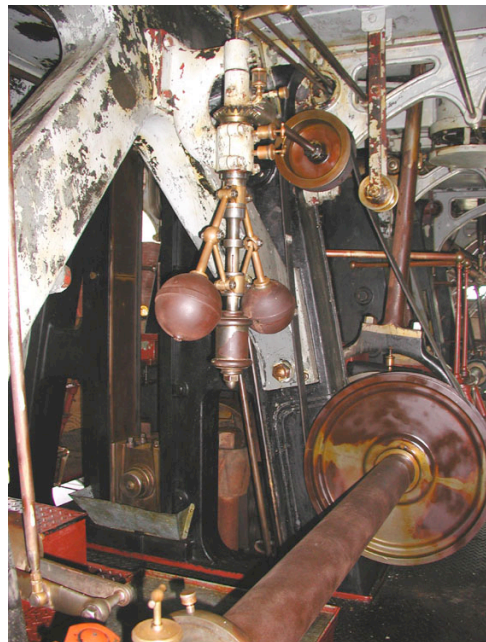
Allis Floor 2 mid detail D east side after treatment.

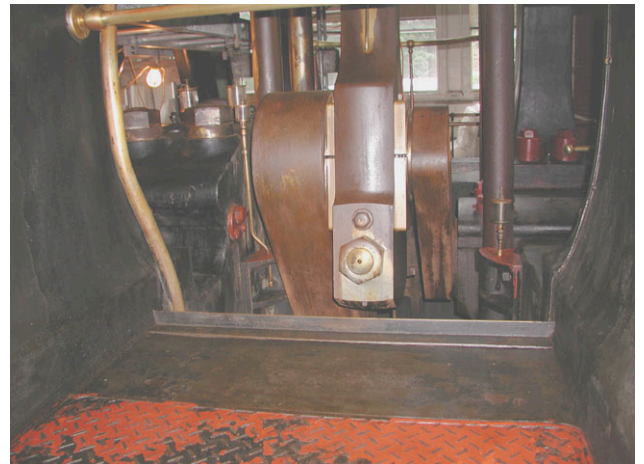
Allis Floor 1 North detail D, east side after treatment.

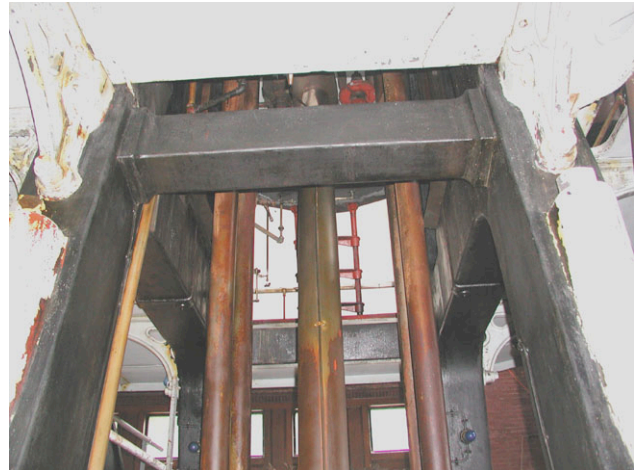
Allis Floor 1 North detail F, east side after treatment.

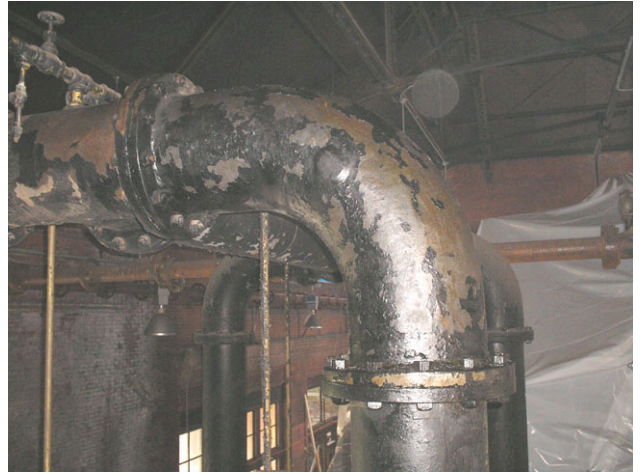
Worthington Floor 3 North
detail B, after treatment.

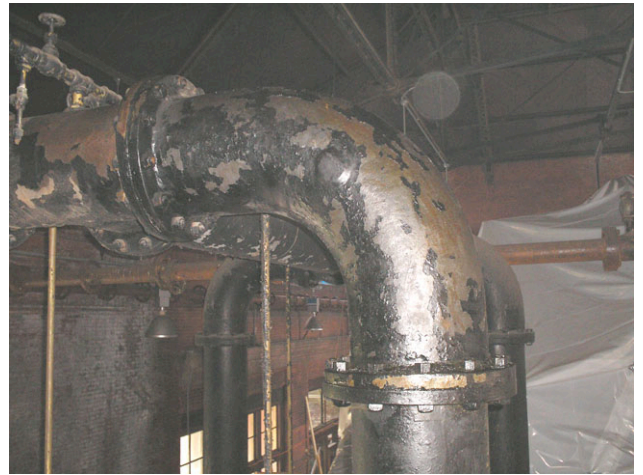
Worthington Floor 3 North
detail B, after treatment.

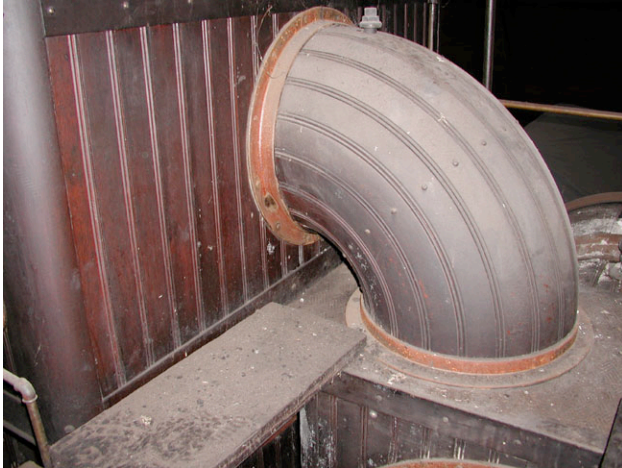
Leavitt Floor 4 North detail A,
looking south before treatment.

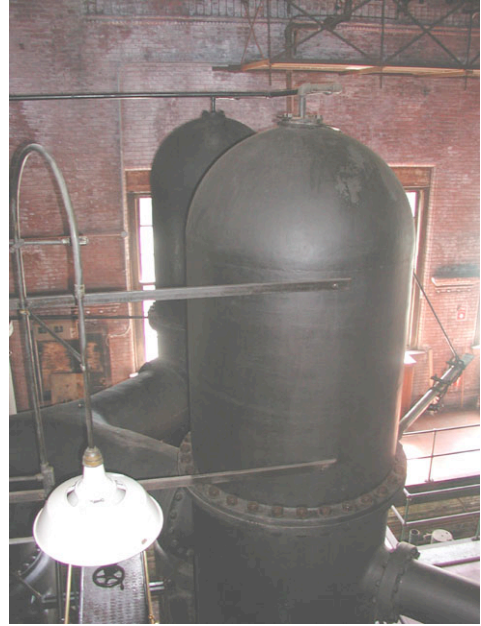
Leavitt Floor 4 South
detail F, after treatment.

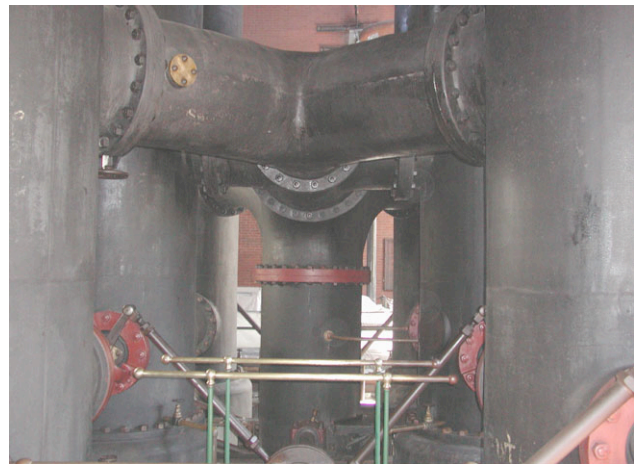
Leavitt Floor 3 South detail H, after treatment.

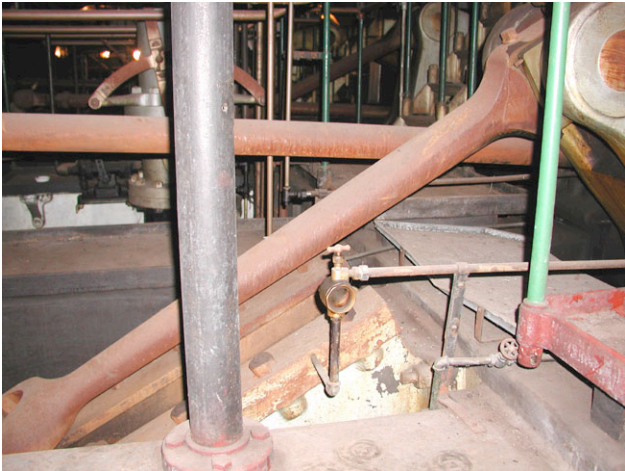
Leavitt Floor 2 North end detail C, east side before treatment.

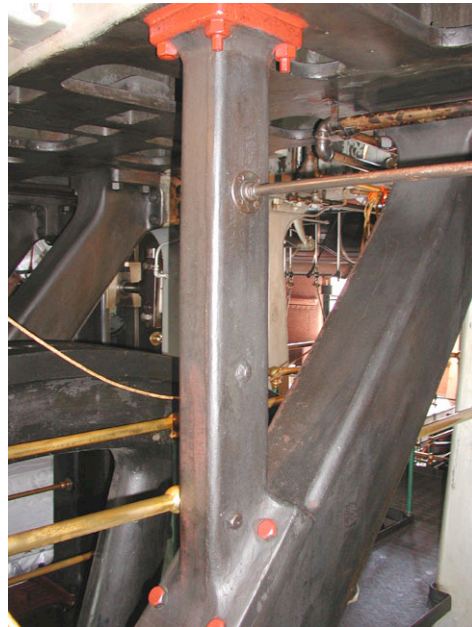
Leavitt Floor 2 North end detail F, after treatment.

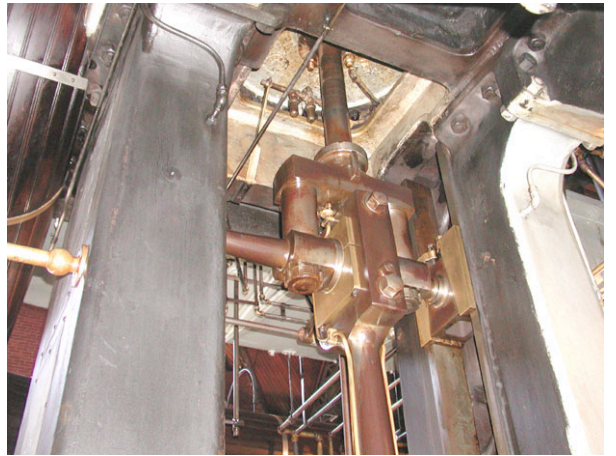
Leavitt Floor 1 North end detail B, after treatment.

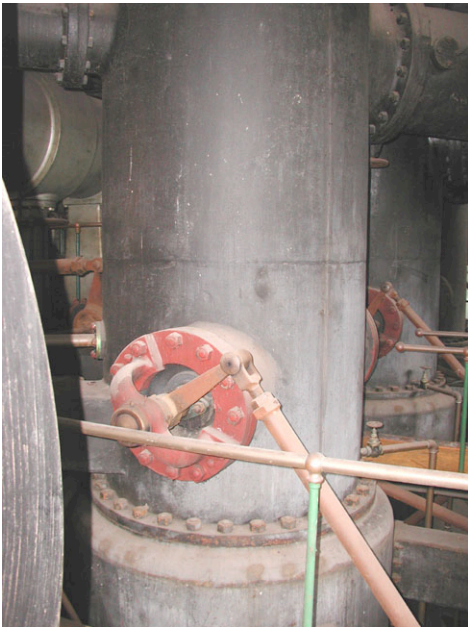
Leavitt Floor 1 South end detail K, west side before treatment.

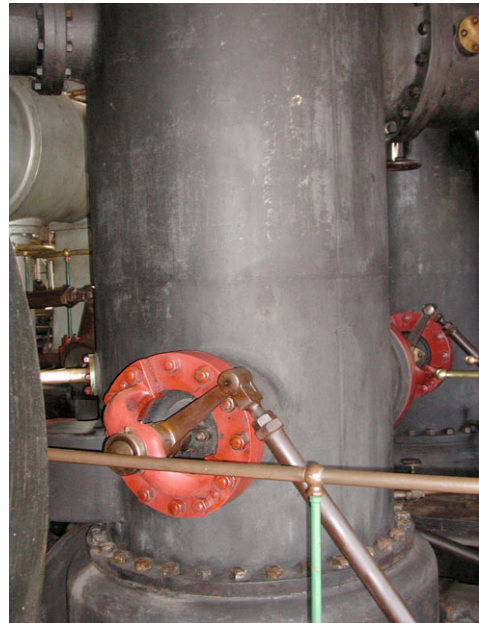
Leavitt Floor 1 South end detail L, after treatment.
